STAGE 1 PRELIMINARY UXO RISK ASSESSMENT

Report Ref: PRA-25-2717 | Author: WS | Reviewer: CB

Client:
Project: London
Date: 24/04/2025

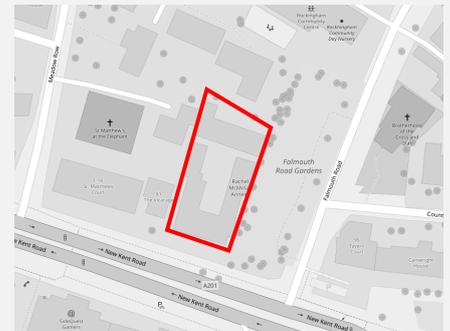
Location: Situated in Elephant and Castle, within the London Borough of Southwark, approximately 150m north-east of Elephant and Castle railway station.

Site Composition: Comprises multi-storey residential university accommodation in the north, east south and west, with a hardstanding courtyard in the centre.

Surroundings: Bound to the north and east by open ground, to the south by New Kent Road, and to the west by St Matthew's Church and a residential structure on New Kent Road.
